PantoCheck Measurements

Automatic video inspection system for Pantographs

The complete solution for checking the pantographs

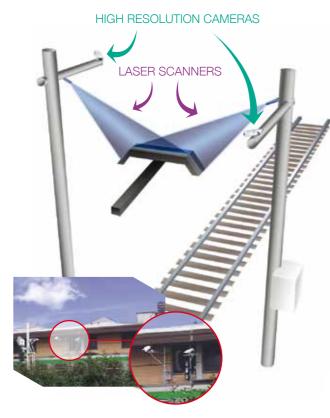
Video and laser system able to make an automatic control of each pantograph when the train is passing.

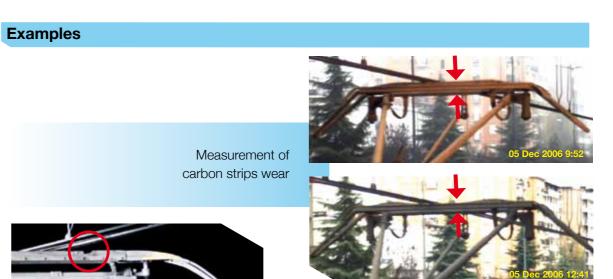
Damage on the pantograph
